Shrinkage-Compensating Concrete in Post-Tensioned Buildings

A Four-Building Survey – Part One

By Kenneth B. Bondy, S.E., FACI

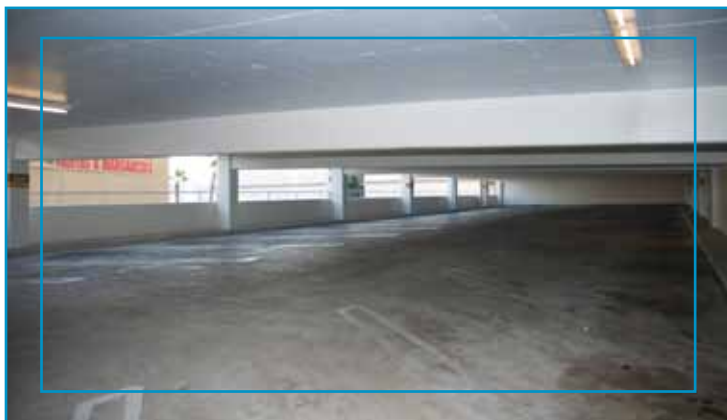
Figure 1: Beam and Slab Framing (4th Level).

Each building was designed for eight elevated levels; four to be built initially, with the capacity for an additional four levels to be added as the need for parking increased. Floors were framed with monolithic cast-in-place post-tensioned lightweight concrete using one-way slabs spanning to clearspan beams (Figure 1). Plan dimensions are approximately 150 feet (three beam spans) by 200 feet (9 slab spans.) One slab construction

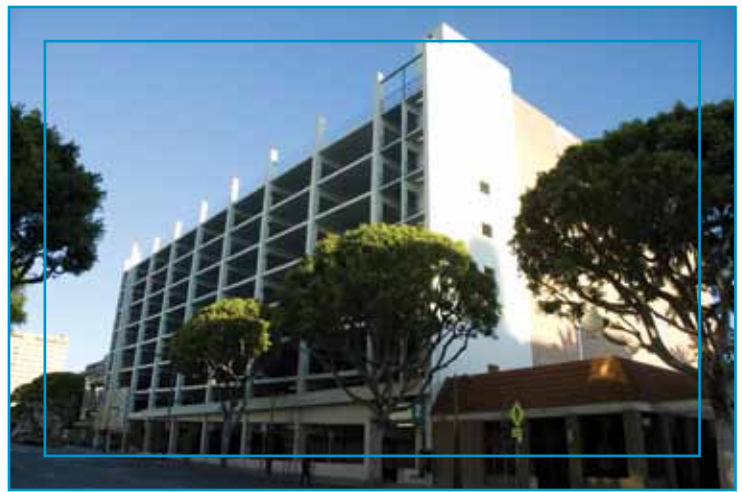
Santa Monica Parking Structure #2.

I inspected the entire floor area of Structure #2 in November, 2009, 41 years after completion of the lower four floors. I carefully observed the areas most susceptible to cracking: the four corners, two with stair/elevator shafts and two without, the ends of the central longitudinal concrete shearwalls, and the areas around the girder framing at each turn-around aisle.

I measured a total of 80 lineal feet of cracks in the lower four floors built with shrinkage-compensating concrete. All of this cracking was on the first elevated slab in the northeast and southwest corners of the building, near the two elevator/stair shafts. The orientation of cracking was consistent with RTS, aggravated not only by the shafts, but by the proximity of a length of basement wall in each location. The largest crack width I measured was $\frac{3}{32}$ inch and the longest crack length was about 18 feet. The cracks were visible at the top and bottom of the slab (when both were accessible), and I saw no evidence of efflorescence at the bottom of any crack, suggesting there was no significant moisture penetration. The southeast and northwest corners of the first elevated slab, lacking shafts and basement wall conditions, were crack free.

I saw no cracking in any structural member (slab, beam, girder, concrete shearwall, masonry shearwall or column) anywhere else in the lower four floors. I observed some minor spalling between the edge of the slab and the masonry wall at the northeast stairshaft at a few levels. Most experienced observers would rate the condition of these lower floors as excellent, with less than 100 lineal feet of cracking in about 120,000 square feet of elevated deck. This is particularly impressive considering the structure has been extensively loaded and unloaded with automobiles on a daily basis for over 40 years. It has also experienced two major earthquakes of Richter 6.0 or larger (San Fernando in 1971 and Northridge in 1994).

The upper four floors, added at a later date without the use of shrinkage-compensating concrete, contain some widely distributed random cracks, most of them visible on the top level. Of particular interest is a very noticeable crack running in the north-south direction on the top (9th) level at the north end of the building, in the exterior slab span along the grid line separating the west and center aisles. This crack is about 15 feet long, visible at the top and bottom of the slab, measuring $\frac{1}{16}$ inch wide at the top and hairline at the bottom. A similar crack is visible in the asymmetrical location near the southeast corner, but smaller with a measured width of $\frac{1}{32}$ inch at the top of the slab. I did not observe this crack at the same location on any other floor. The crack at the top level may have been aggravated by temperature effects since it is fully exposed to the environment, but the presence of this crack on a floor built with conventional concrete, and its absence on lower floors built with shrinkage-compensating concrete with more severe RTS conditions, suggests that shrinkage-compensating concrete made the difference.
